**CALIFORNIA REGIONAL WATER QUALITY CONTROL BOARD - SAN DIEGO REGION
WATERSHED MANAGEMENT PROGRAM**

FACILITY INSPECTION REPORT

Sprinter Rail Project

FACILITY: North County Transit District Sprinter Rail (WDID) 9 37C322900 INSPECTION DATE: 11/30/07

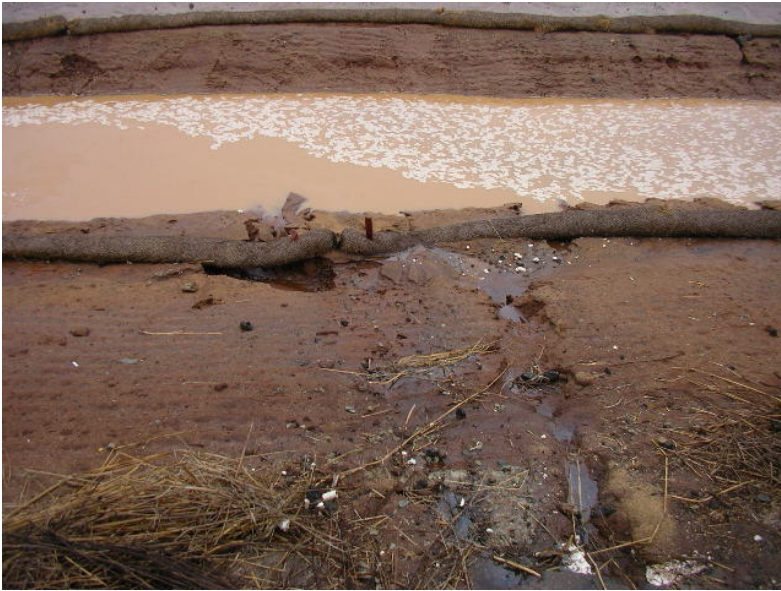
672. A closer look at the erosion in photo 671.

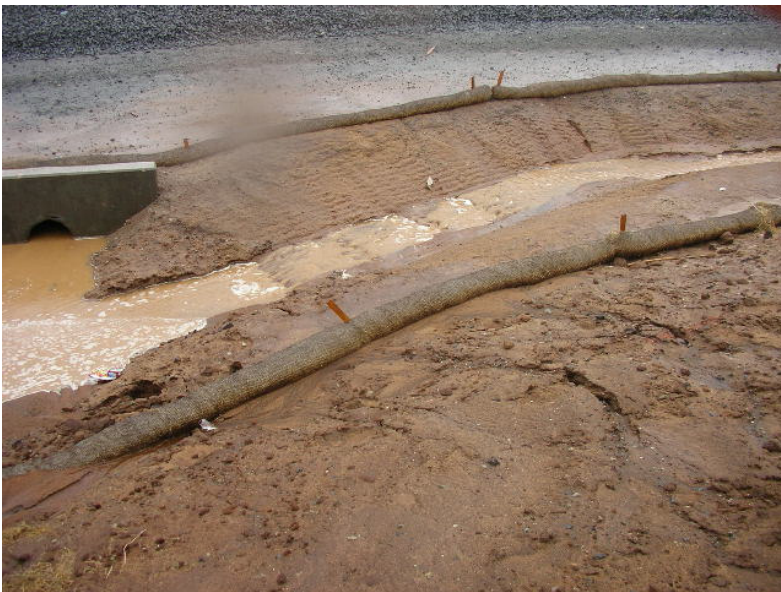
673. The bed of the unlined dirt channel is eroding away.

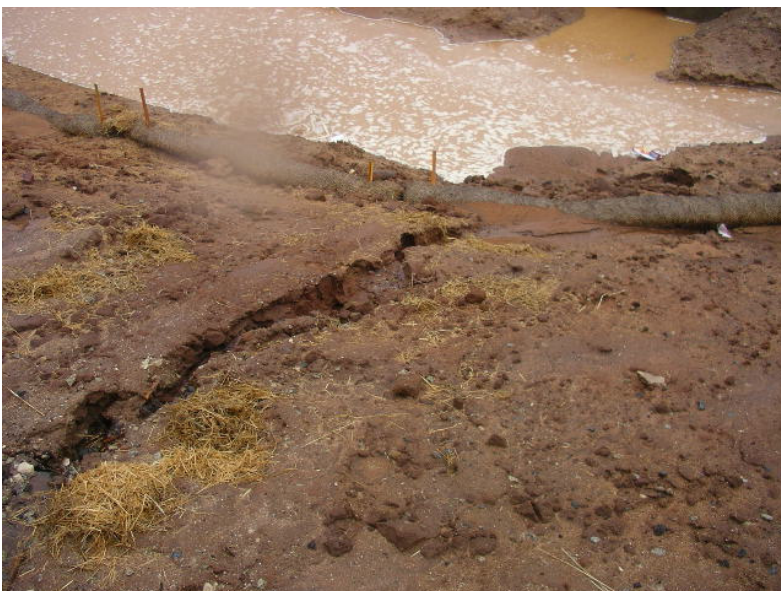
674. Gully erosion runs down the slope to the unlined dirt channel.

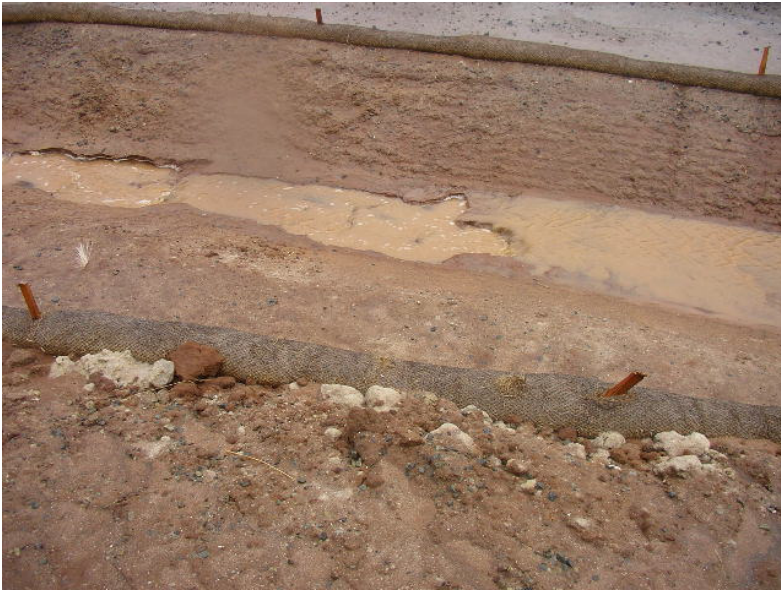
675. The bed of the unlined dirt channel is further eroding away.

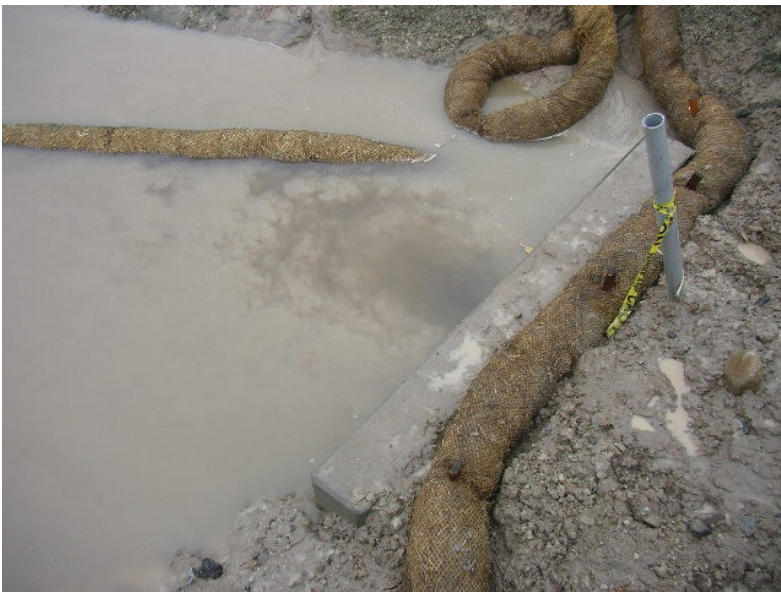
679. This is the inlet receiving the sediment laden water in photo 678. The inlet has backed up and clear water was bubbling out.

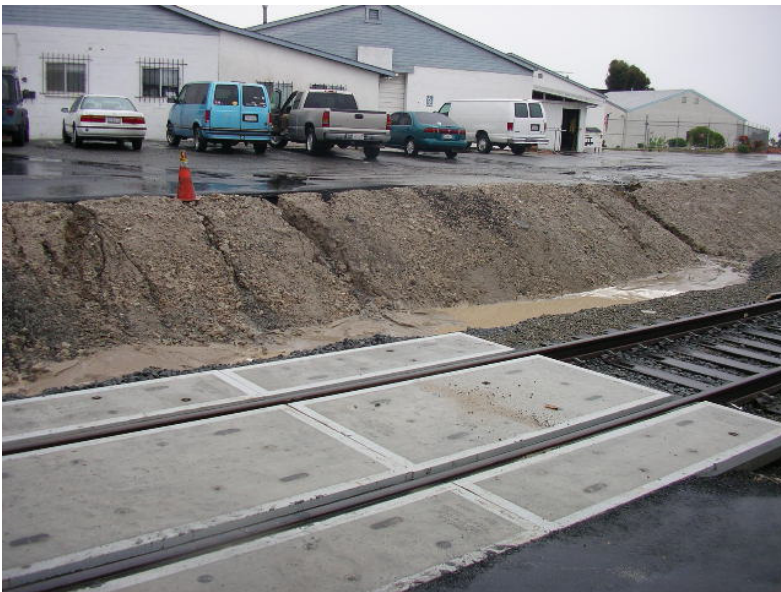
686. A slope with no erosion or sediment controls has large gullies.

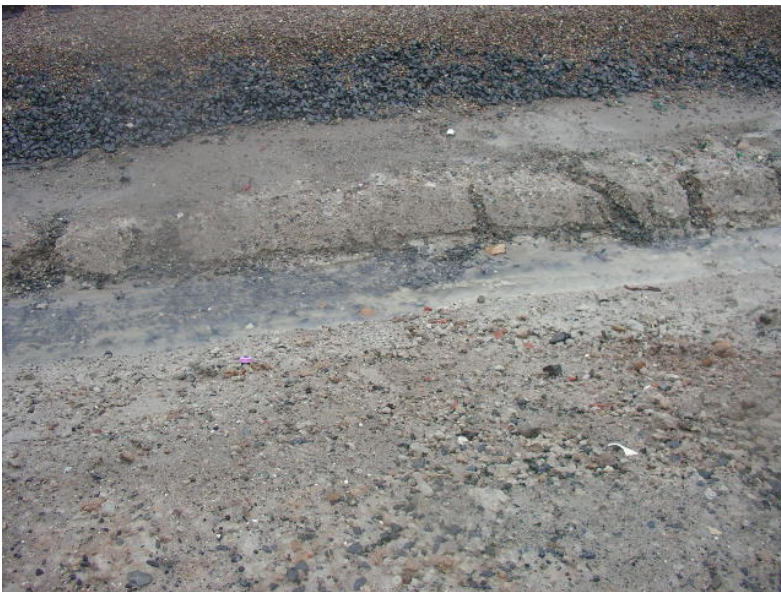
690. The storm water in the channel is clear on the left of the photo and then picks up sediment as it flows to the right in the unlined dirt channel.

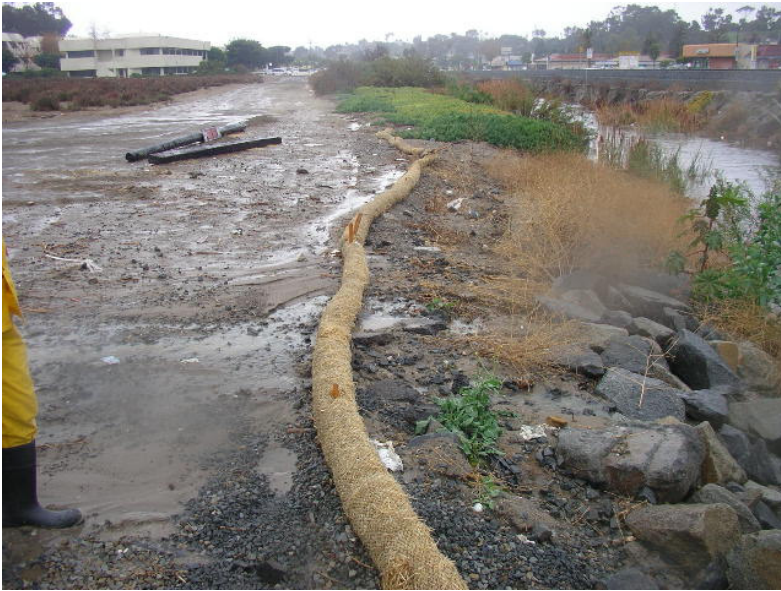
695. Fiber roll along the top of the bank to Loma Alta Creek has not been trenched in.

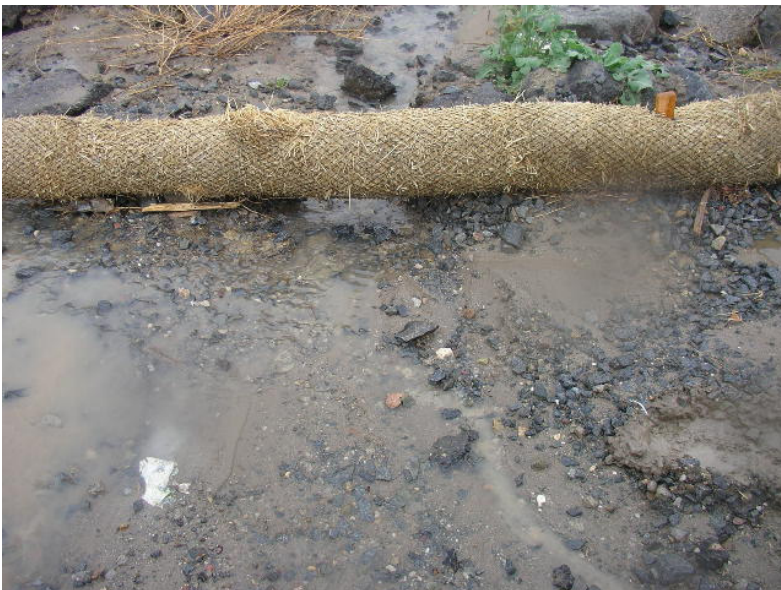
697. Sediment laden water from the construction site is running under the fiber roll in photo 695 and discharging into Loma Alta Creek.

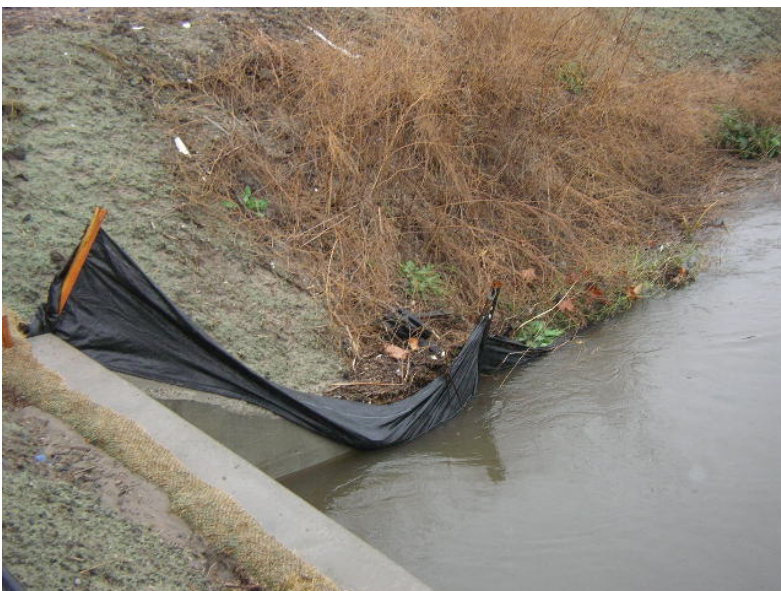
711. Silt fence is in need of maintenance.

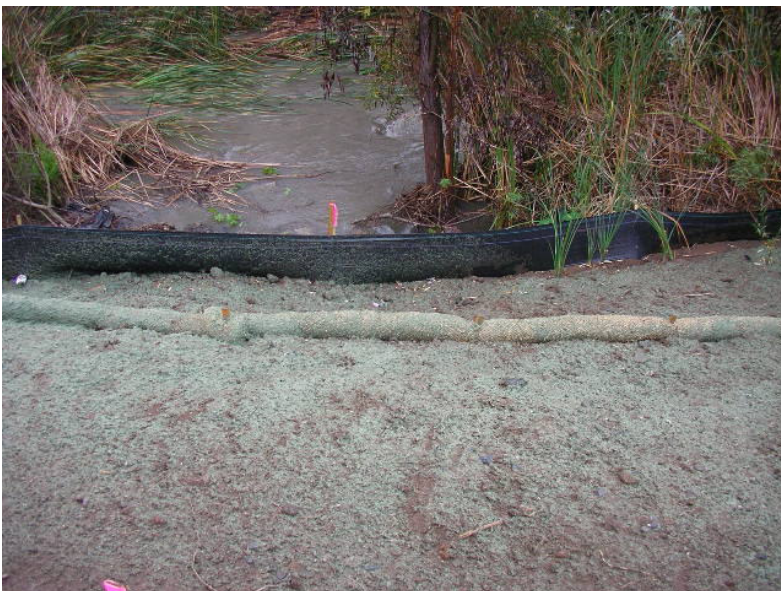
714. A light application of erosion control spray on the bank above Loma Alta Creek.

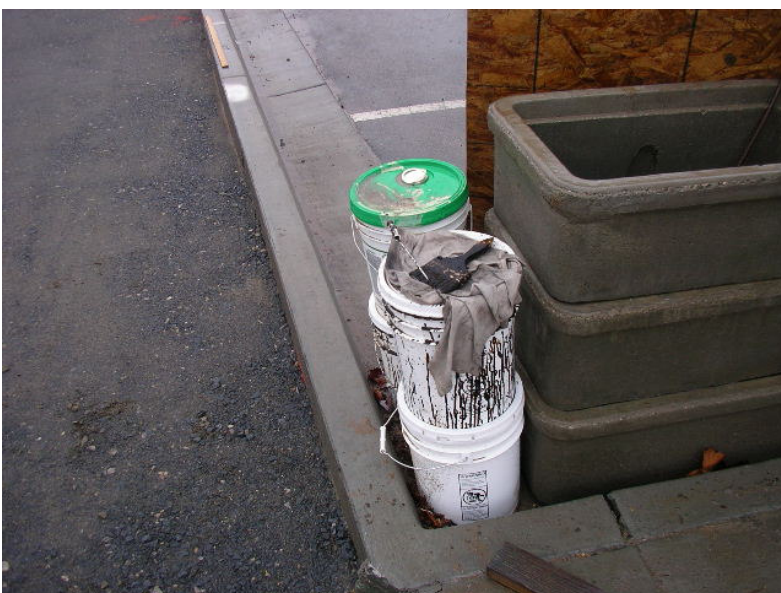
717. Construction material has been left out exposed to storm water.

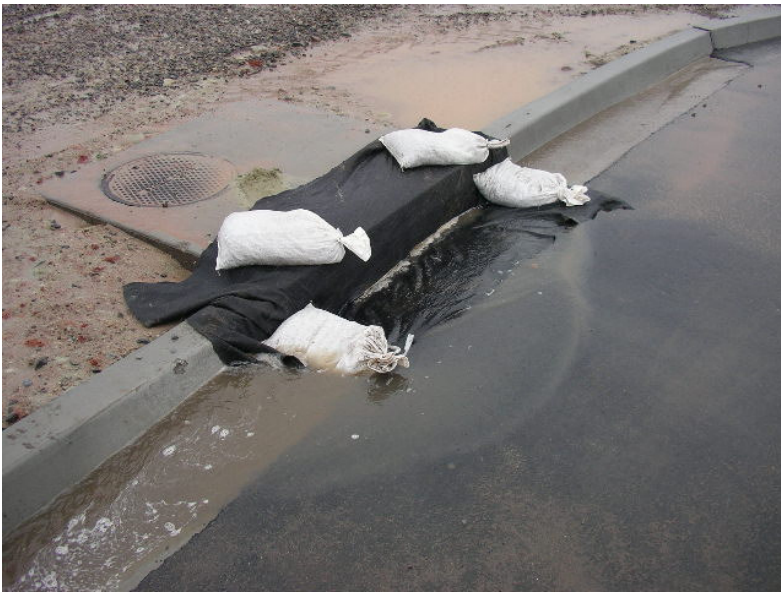
7. Melrose Station, Oceanside – A storm drain inlet had inadequate levels of gravel bag protection (Photo 718). No gravel bag chevrons were present upstream from the flow seen in this photo. The construction exit had been stabilized since the last inspection (Photo 719). The storm water entering the storm drain inlet in photo 718 was sediment-laden (Photo 720). A soil stockpile had been covered since the last inspection (Photo 721). Erosion control was implemented on some of the slopes but the application ended and did not continue on slopes further down the tracks (Photo 722). A storm drain inlet near the station platform noted in a previous inspection was protected with filter fabric (Photo 723). The source of sediment entering the storm water in photos 718 and 720 was found to be from a curb cut out for handicap accessibility (Photo 724). The pavement had not been poured for the handicap ramp. Storm water entered the curb cut out; then the storm water mixed with the dirt pooled and spilled back out into the gutter. A storm drain inlet was without adequate gravel bag protections and needed maintenance (Photo 725). Another storm drain inlet in this station's parking lot did have adequate storm drain protections (Photo 726). The water entering the inlet appeared clear and free of turbidity, suspended solids or sediment. A storm drain inlet surrounded by non-stabilized soils was blocked off with gravel bags (Photo 727). Surprisingly although it had been raining all day, this storm drain did not have a pool of water around it. The erosion control applied in this area appeared to be light (Photo 728).

718. A storm drain inlet's protection needs maintenance.

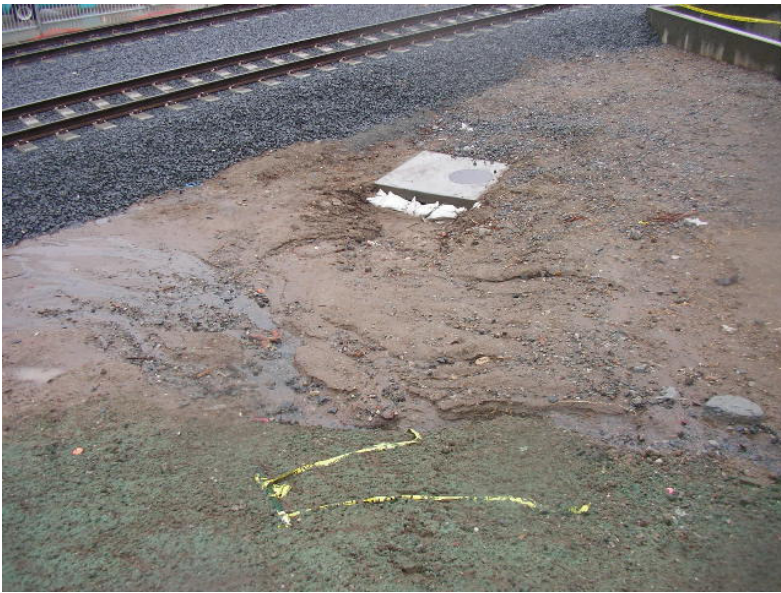
727. Storm drain inlet is blocked off with gravel bags. No ponding water suggests that storm water flowed elsewhere.

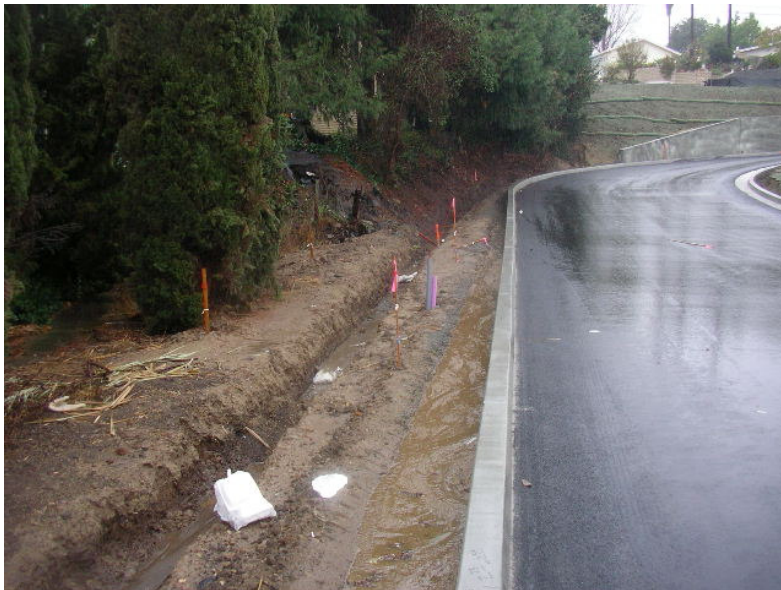
734. An unlined dirt channel down the hill leads to the storm drain inlet in photo 733.

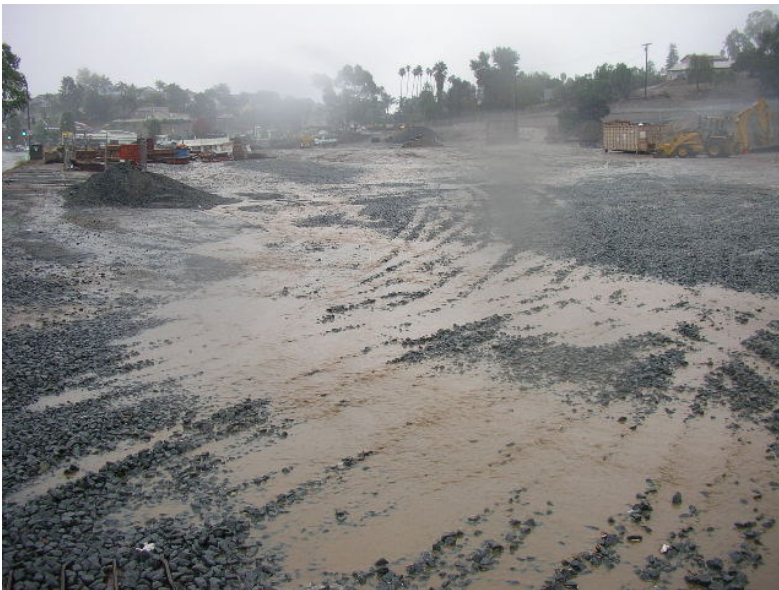
742. Sediment laden water from the construction storage yard flowing towards the storm drain inlet in photo 746.

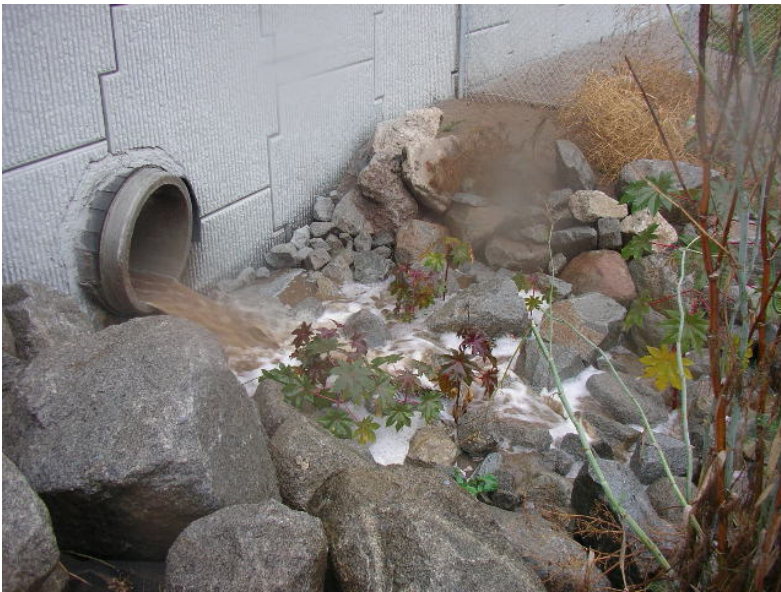
749. Storm water run on not addressed to prevent contact with disturbed soil areas in the construction storage yard.

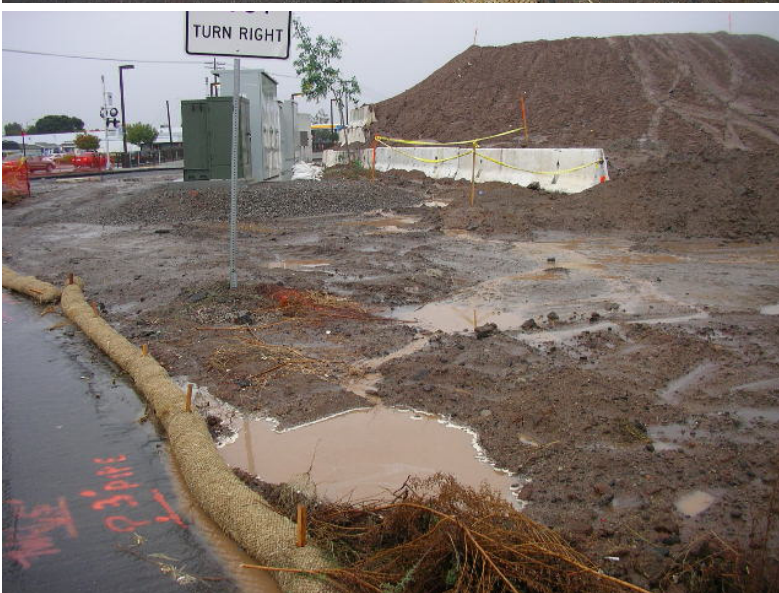
14. Nordahl Road Station, Escondido – Sediment-laden water was discharging off the site into the City's storm drain gutter (Photos 764 and 766). Fiber roll was not trenched in and failed to prevent discharge (Photo 765). Throughout all of the Sprinter Rail construction site, construction equipment did not have drip pans under them when not in use to prevent oil and grease leaks from contacting storm water (Photo 770). A water truck was improperly parked in a low area with ponded water (Photo 772).

765. The source of the sediment laden water discharging in photo 764.
